## 24/7 MAX AIRFLOW IN 288 ft.<sup>2</sup> BOTTOM UNIT

DOCUMENTED JET BLACK MOLD DIRECTLY  
IN LINE OF AIRFLOW

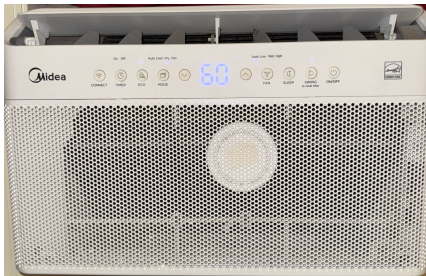
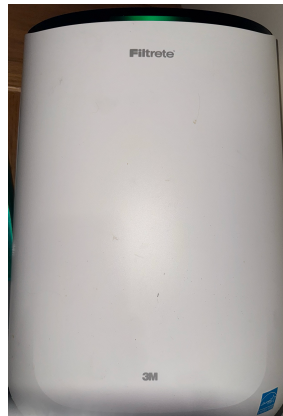
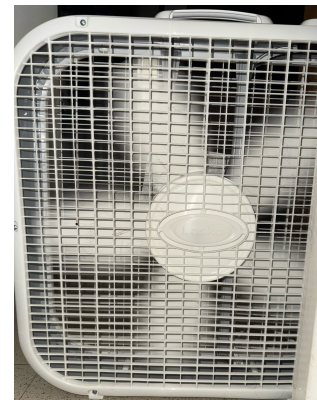
- MIDEA AC W DEHUMIDIFIER
  - MAW08U1QWT (8,000 BTU) **350 ft.<sup>2</sup>**
- FILTRETE 3M AIR PURIFIER
  - FAP-ST02N **310 ft.<sup>2</sup>**
- 20" BOX FAN

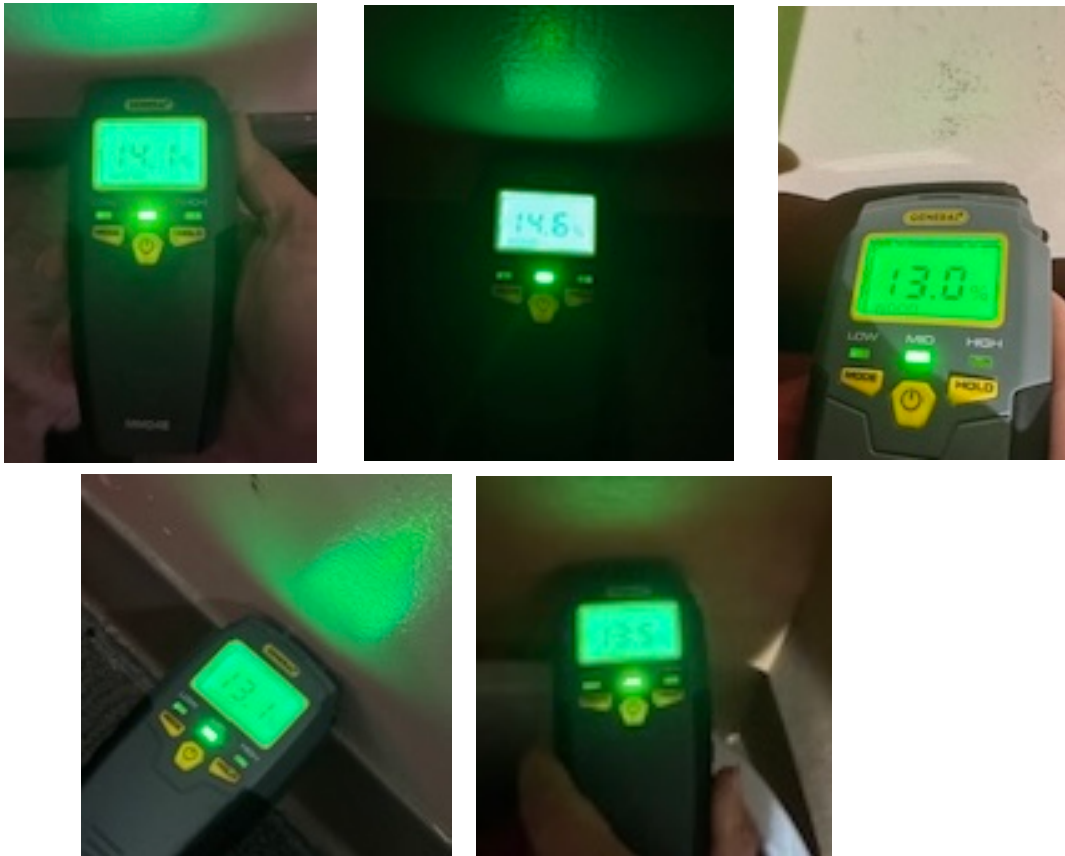
AG CAMPUS SAYS THE FOLLOWING ABOUT  
THEIR CONTINUOUS 13.1+ DRYWALL  
MOISTURE READINGS:

*“We have attached the moisture readings taken during our recent inspection, all of which fall within normal ranges. There is no indication of elevated moisture levels that would support your claims of structural mold. Any reputable and licensed company you choose to hire for an inspection will likely reach the same conclusion.”*

“If your moisture readings are consistently 13 across multiple wall locations using that meter, it suggests your walls are actively retaining moisture, even with dehumidification and airflow running nonstop.

- Drywall should read well below 1% moisture by weight—or low single digits if the meter’s on a reference scale. A “13” repeated across multiple points isn’t just background humidity—it points to possible trapped moisture, either from past leaks, rising damp, or vapor intrusion through compromised building materials.
- When readings are uniform across zones, it often means systemic infiltration, not just a localized event. This could be condensation behind paint layers, slab-driven moisture, or unsealed thermal bridging.
- With your setup actively drying the air and circulating particles 24/7, the fact that moisture persists implies that the source is internal, structural, or unresolved—not atmospheric.”

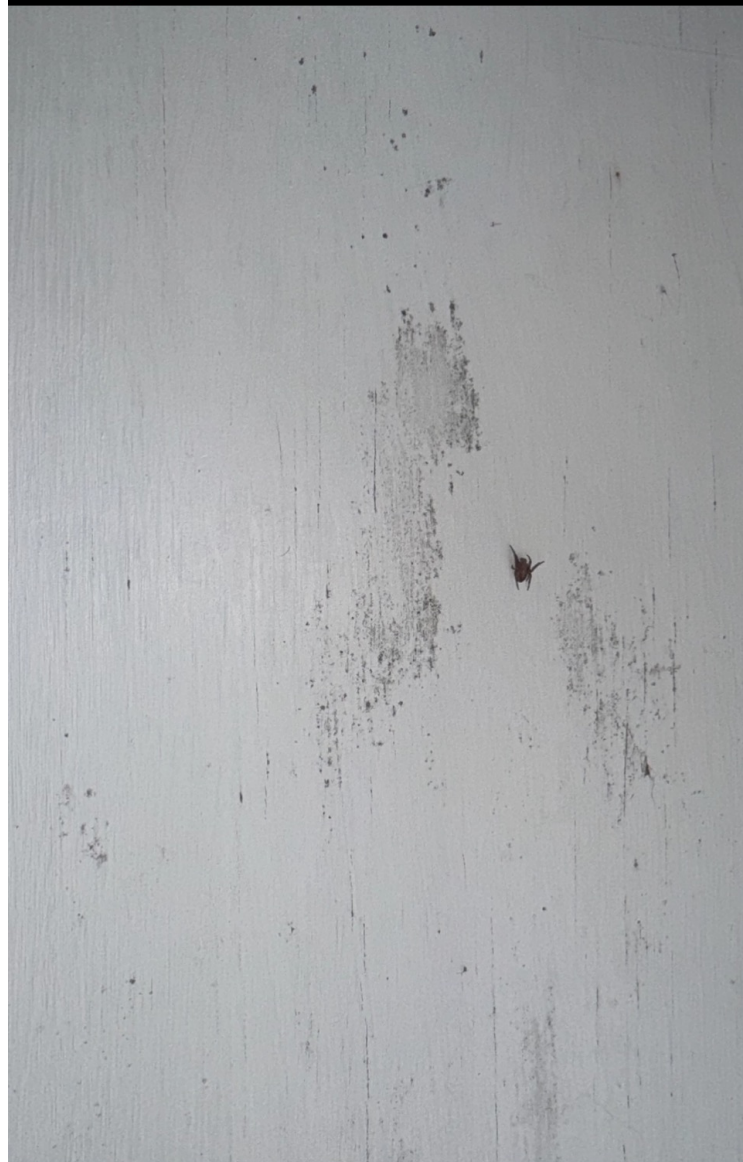
**This is the underside of the patio above me at 1840 Onyx Alley A. There's spots spanning the entire patio.**

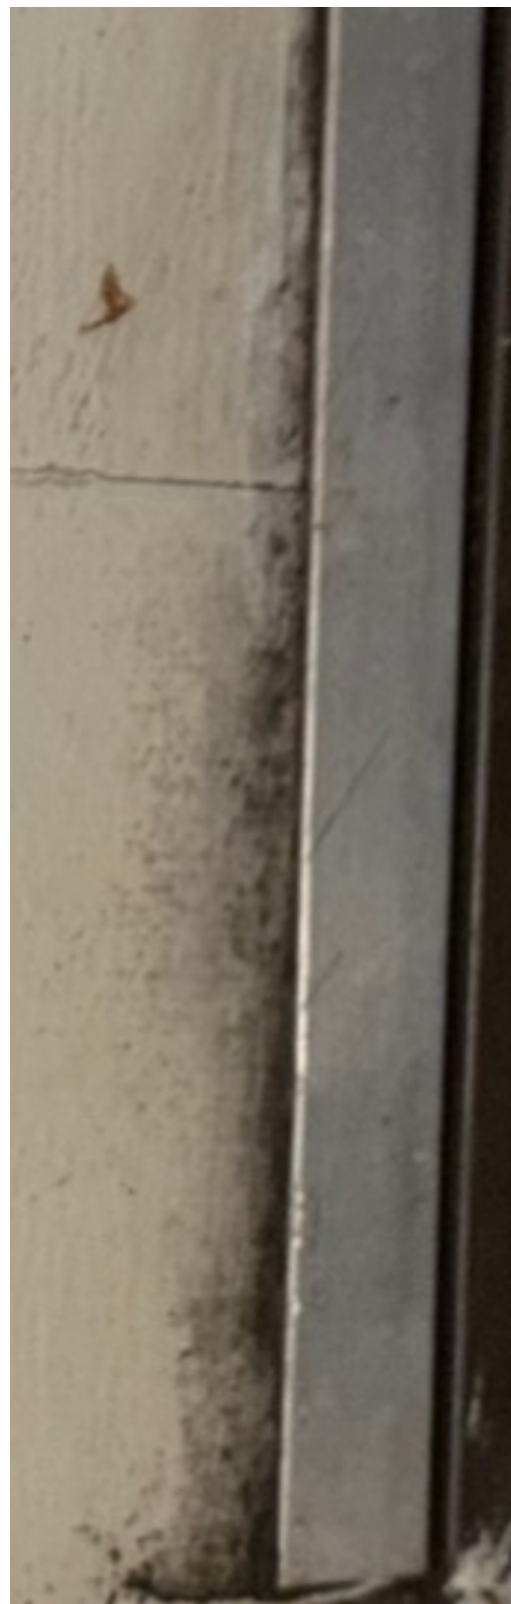
**I created a "catio" for my ESA on my patio. Seeing this located above where she sits often is concerning.**
